Grab Groundwater Sampling Photos
SP-GW-04

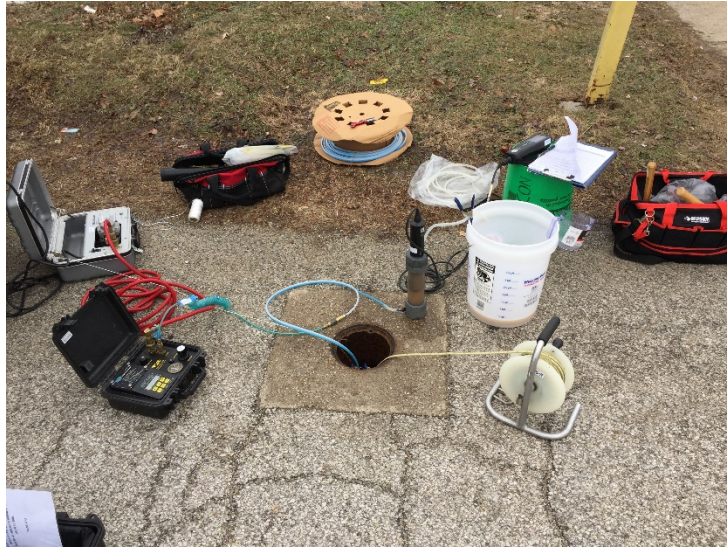
Photo No. 1

Description: This photo shows the set up for low-flow groundwater sampling at monitoring well MW-003.

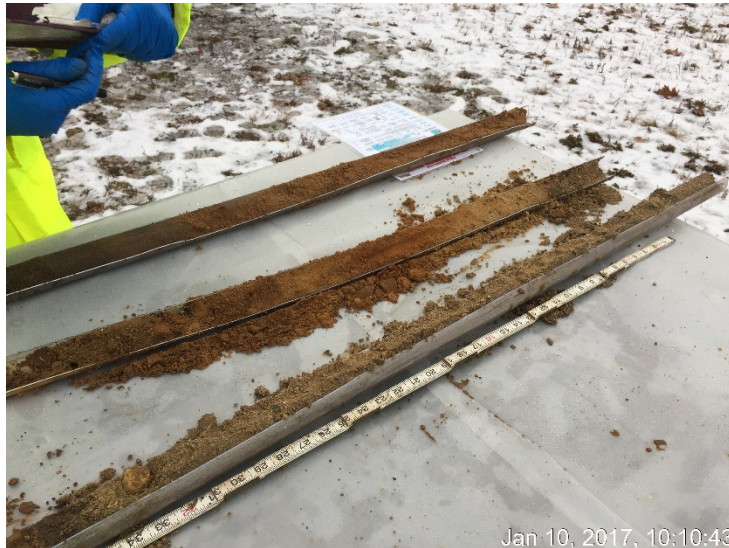
Photo No. 2

Description: This photo shows the soil borings from SP-GW-01. Sterns Drilling placed the soil borings in order on a table for SulTRAC to describe at all locations.

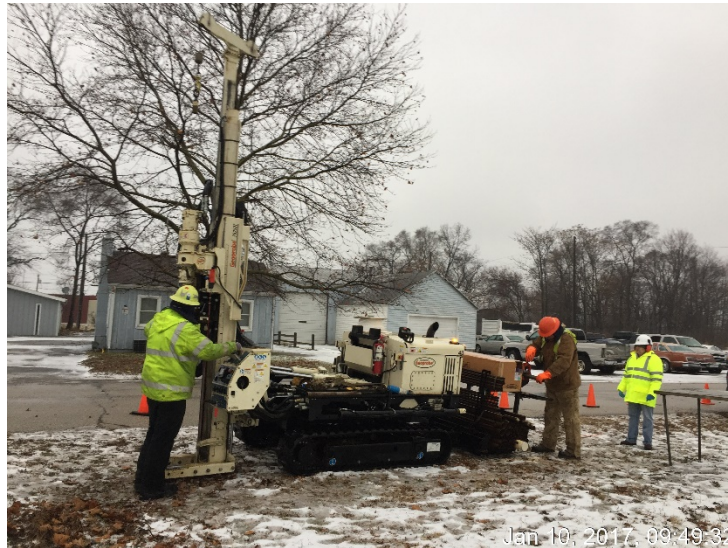
Photo No. 3

Description: This photo shows how the drill rig was set up at the temporary sampling locations.
